APRIL 2015

ADA/ACCESS MANAGEMENT/TRAFFIC ASSESSMENT REPORT

US 211/US 17/29 BUS (BROADVIEW AVENUE) ACCESS MANAGEMENT IMPROVEMENTS

FROM SOUTH OF FROST AVENUE TO
SOUTH OF WINCHESTER STREET
TOWN OF WARRENTON
FAUQUIER COUNTY, VIRGINIA

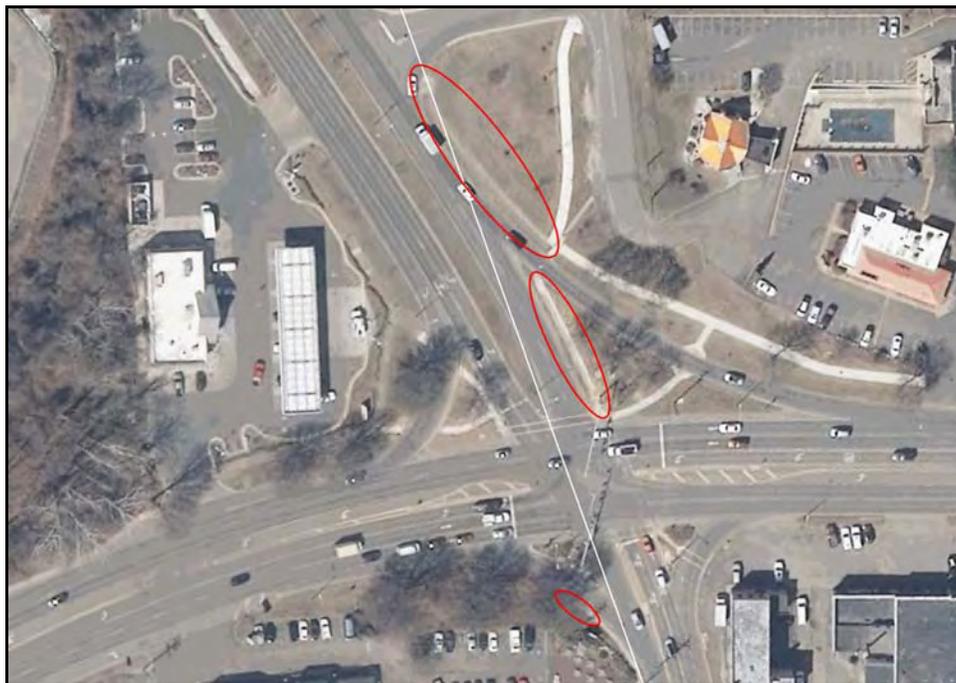
Figure 2 – Frost Avenue/Waterloo Street Intersection Sidewalk

There are three locations where there is a 4-foot sidewalk width near the Frost Avenue intersection. This occurs in the southeast quadrant, on westbound Frost Avenue beyond the dedicated right turn lane from southbound Broadview Avenue, and a couple of small lengths of sidewalk within the median island in the northwest quadrant (See **Figure 2**).

The Design Team recommends replacing the noted segments of 4-foot sidewalk to provide at least a 5-foot sidewalk width where feasible. According to the p. A109 of the *VDOT Road Design Manual*, if the area is deemed “technically infeasible”, then the minimum clear width of 4 feet shall be provided and a Design Waiver will be required for these areas. No sidewalks less than 4 feet in width will be included in the proposed improvements.

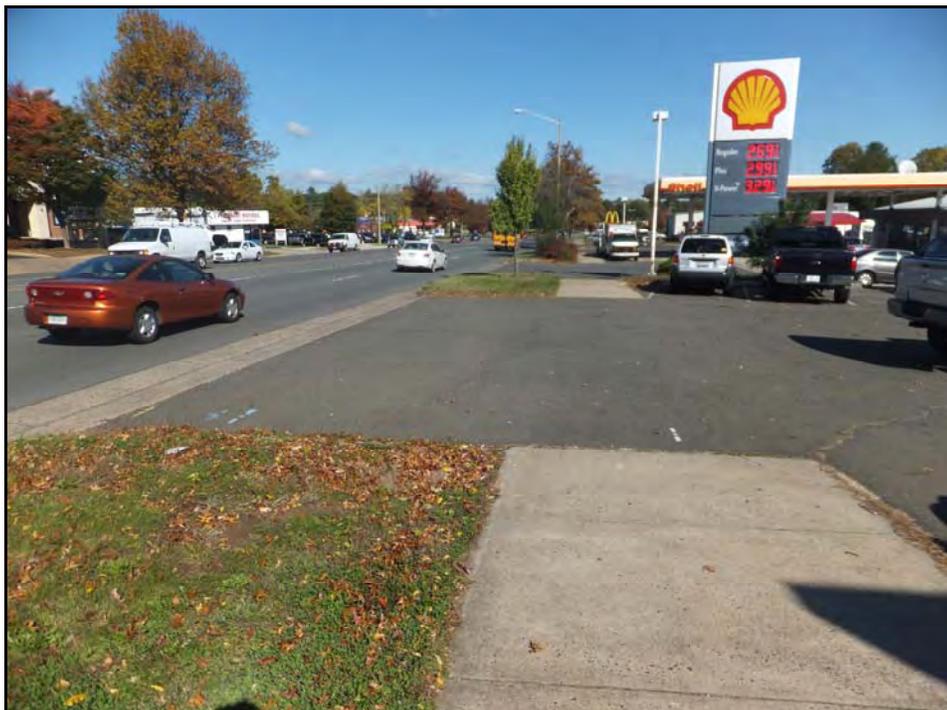
Figure 3 – Deficient Driveway Cross Slopes

Reconstruction of an entrance to meet VDOT standards at the edge of pavement is considered a Critical Improvement. Only one entrance location (Trusted Auto Care, Sta. 50+25, Right) was observed to be deficient in cross slope at the edge of pavement (see **Figure 3**). Reconstruction of this driveway entrance is recommended to correct this deficient condition.

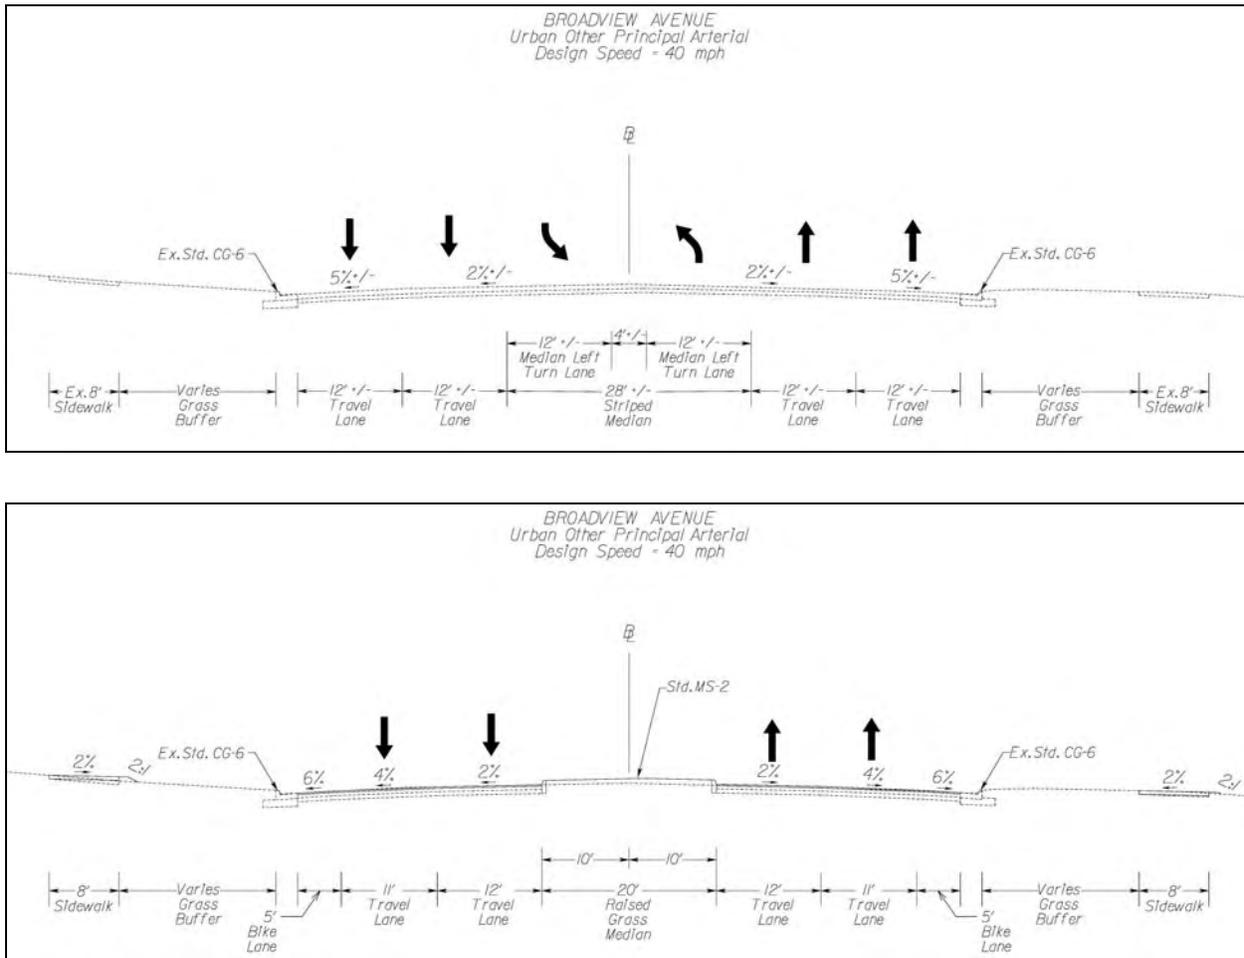
Figure 4 – Existing and Proposed Roadway Typical Section

Investigation of the existing roadway section indicated that Broadview Avenue is not compatible with any level of bicycle traffic.

The Design Team has coordinated with VDOT in the development of a new proposed roadway typical section, maintained within the existing closed section footprint of Broadview Avenue (see **Figure 4**). The proposed typical section will provide 5-foot bike lanes in order to accommodate all potential bicycle users in accordance with the VDOT Road Design Manual. Appropriate traffic control will be incorporated to provide proper guidance to both bicyclists and motorists.
